**Arboricultural Report  
Proposed Development at  
The Lord Mayor's Public House  
Main Street  
Swords**

**February 2019**

**The Tree File Ltd  
Consulting Arborists  
Ashgrove House  
Kill Avenue  
Dun Laoghaire  
Co Dublin  
01-2804839**

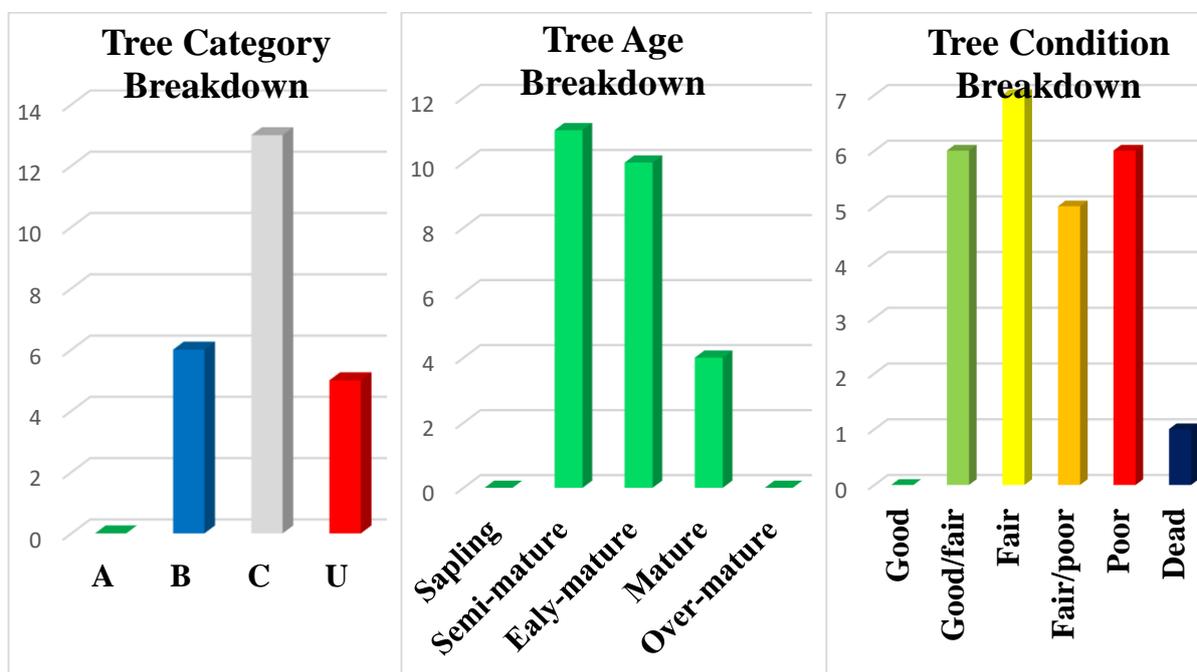
As can be seen from the graphs below, tree qualities tend to be somewhat mediocre overall. The age profile tends to be very young, with much of the site dominated by new planting of natural regeneration. It is only the site’s hedges that add an notable maturity. Notwithstanding the site’s broadly young age profile, the condition breakdown shows now dominance of better condition trees, with the overall breakdown being notable spread over a wide array of conditions.

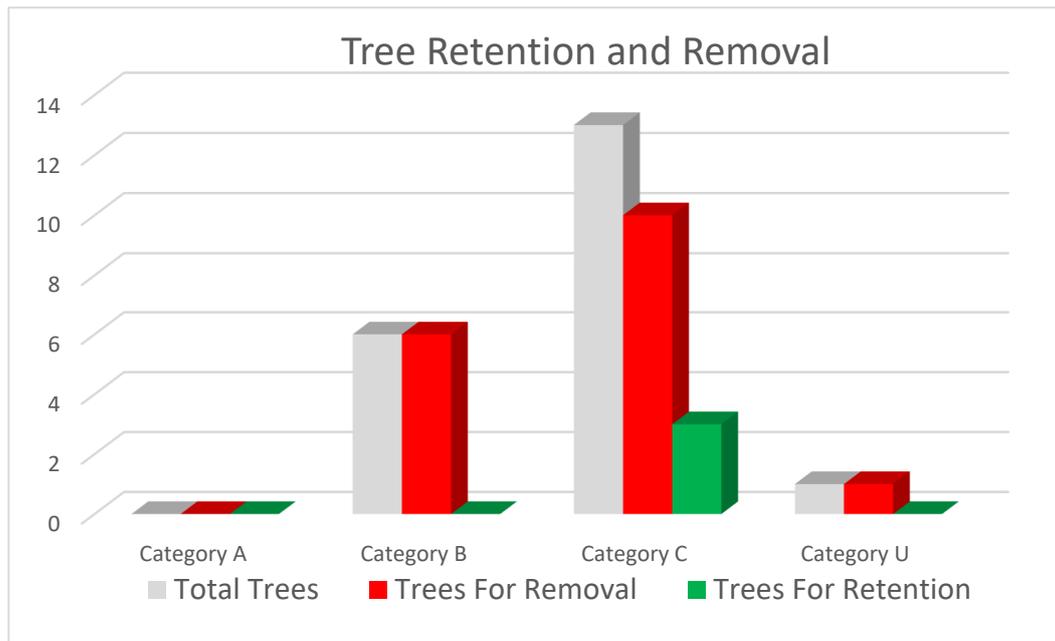
Of the above vegetation, a majority will be removed including all hedge, scrub and thicket material, however three trees to the north of the site area will be retained, including Common Alder No.1919, Crack Willow No.1920 and Sycamore No.1921.

The drawing “D2-AIA-Swords-02-20” comprises the tree survey drawings overlaid by the development drawings, thus providing a graphic representation of the tree related impacts, with those trees that will be removed, being denoted by red dashed outlines.
